USER: Carrying Firm

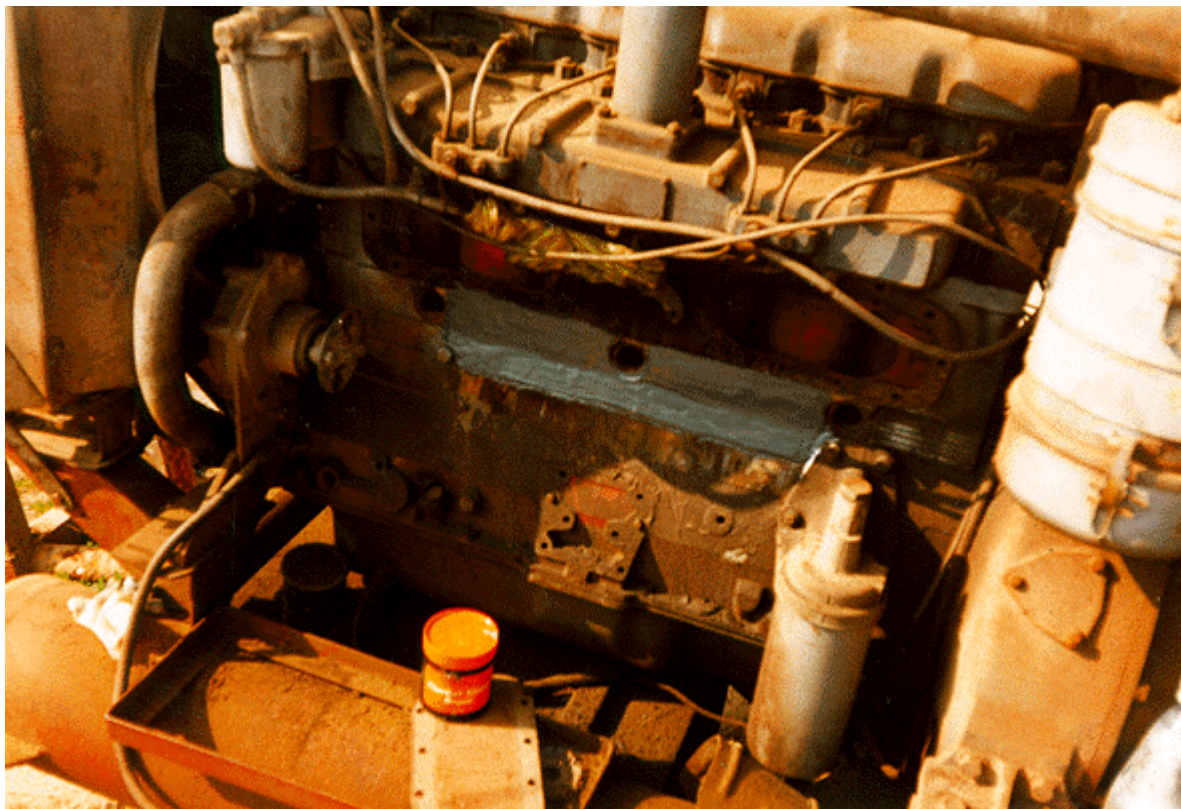
**DESCRIPTION OF THE PROBLEM:** The Diesel engine block, propelling the air compressor, cracked as a result of the water freezing. There was detected the main crack of the length of ca. 40 cm and three smaller cracks of the length of ca. 4 cm towards the engine head.

**DESCRIPTION OF THE REPAIR:** All cracks were cleaned along 4 cm at each side with the help of a grinder, made rough, and then degreased with the help of **Chester Cleaner**. Holes were drilled at the ends of the cracks, with the diameter of 3.5 mm. **Chester Metal Super** was applied on the surface prepared in such a way forming a layer of 2mm thick and there were applied the so-called 2 mm thick layers of steel sheets. The sheets were cleaned, defatted with **Chester Cleaner** and there was applied a layer of **Chester Metal Super**. Everything was covered with **Chester Metal Super**.
