USER: Construction Company,  
Brick Plant

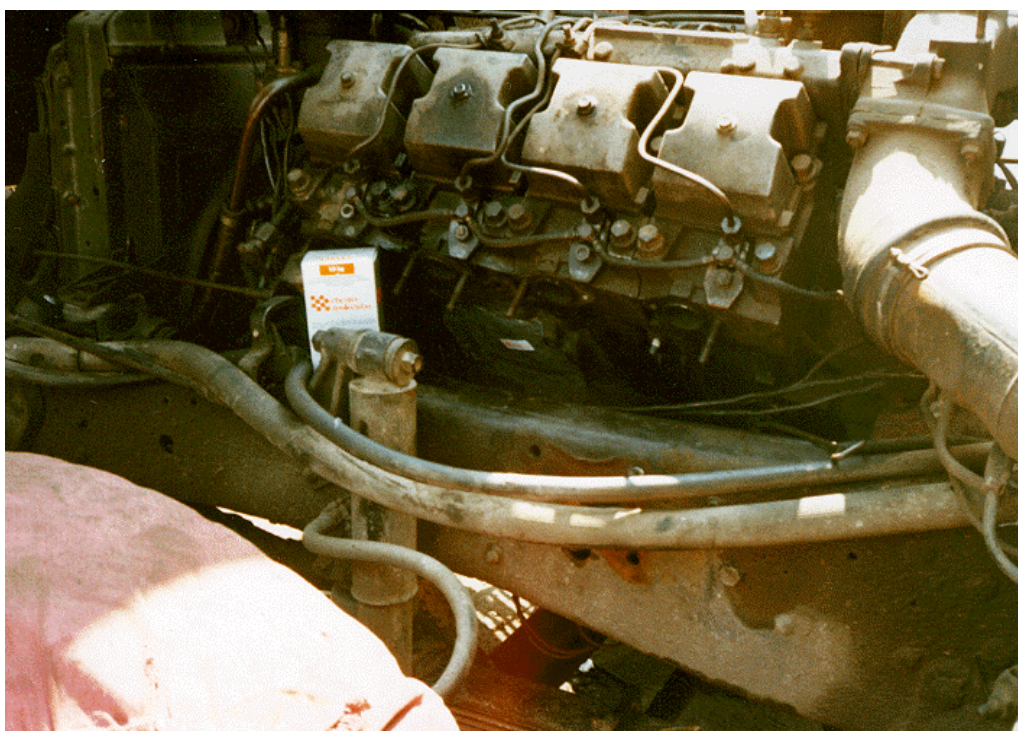
**DESCRIPTION OF THE PROBLEM:** The block of the engine of KAMAZ truck cracked and there appeared a leakage of the cooling water (under the exhaust collector). A previous repair included a welding of a steel sheet between the ridges of the body and a supplementation, sticking of fragments of the lack with an unknown material. The "patch" was not water tight as a whole.

**DESCRIPTION OF THE REPAIR:** The old "adhesive" was burnt out with an acetylene blowpipe, and the body with the plate was carefully degreased with **Chester Cleaner** several times. In spite of taking the water out of the cooler, there appeared a problem of a constant, but small leakage from the crack. The whole place with its surrounding area was polished with corundum shields and cutters. The system and the crack was finally dried by means of a repeated heating and polishing of the cooling water circulation chambers. There was made the final degreasing and there was applied **Chester Metal Super** strengthened with a knitted net of the mesh of 2-3 mm. All the application was smoothed with a wet hand.

**ACHIEVED EFFECTS:** The repair entailing the welding did not assure the water tightness. Regeneration with materials made by Chester Molecular, conducted very carefully, gave the desired effect. In the case of permanent leaks of a liquid through a crack, we recommend to use capillary adhesives (also made by Chester Molecular) with an earlier, at least temporary elimination of the humidity by means of drying or with blows of compressed air.
