**Customer: Coalmine**

**Made by: M.Sc. Eng. Leszek Kupras Chester Molecular Łódź**

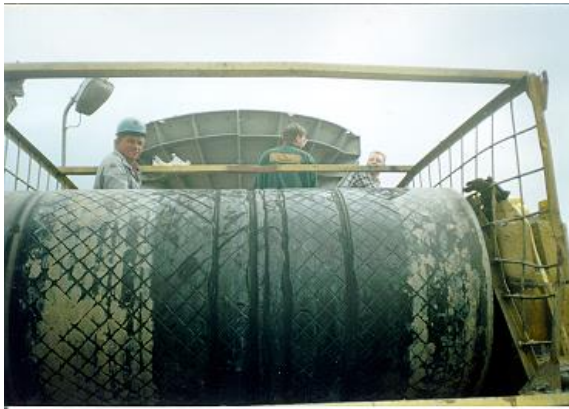
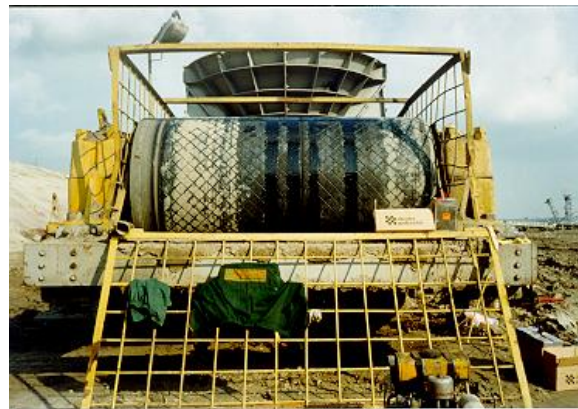
**PROBLEM DESCRIPTION:** The overburden (or coal) conveyors have reversible tensioning rollers, covered with rubber. Periodically, the problem of damage to cladding fragments appears, in this case, there were 4 grooves around the circumference, each approximately 50 mm wide and 15 mm deep.

**DESCRIPTION OF THE REPAIR:** Due to the necessity to extend the conveyor belt, the belt was cut (access to the roller was free). The area of the grooves was cleaned of mud, degreased, and roughened with rotary wire brushes. Degreased again with **Chester Fast Cleaner F-7** and primed with **EL-20M** - cavities were only in the area of rubber. After these preparatory procedures, at 45% relative air humidity, **Elastomer 85T** was systematically applied, successively changing the position of the roller. The elastomer was thoroughly rubbed into the substrate, the loss of rubber was replenished to the actual thickness of the lining. The outer surface of the elastomer was smoothed with a spatula.
