**Customer:** Power Station

**Supervision:** Leszek Kupras - Chester Molecular – Łódź

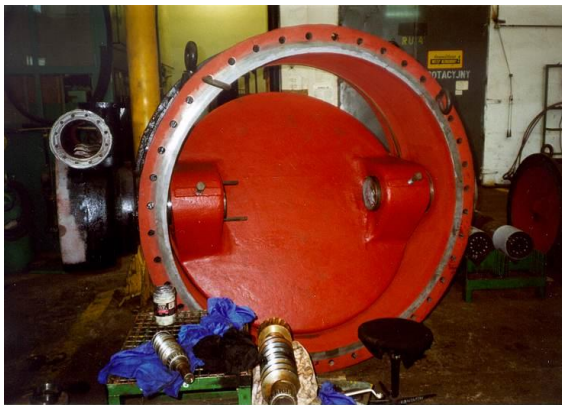
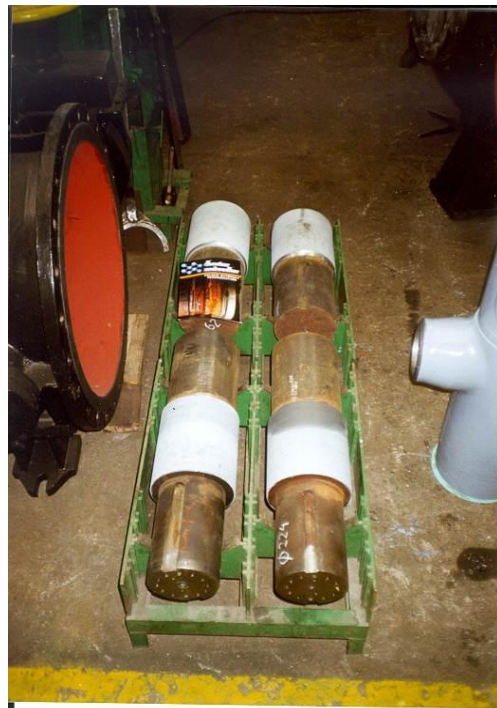
**PROBLEM DESCRIPTION:** The surface of the journals  $\phi$  230 x 250 was damaged by corrosion (despite the protection of water access by the seal). These pins locate and regulate the position of the water damper flap.

**DESCRIPTION OF THE REPAIR:** In order to obtain a uniform journal diameter, a 1.5 mm thick metal layer was removed by machining. In order to obtain good adhesion of the regeneration layer, a coarse thread was cut. The surfaces were degreased with **Chester Fast Cleaner F-7**. **Chester Metal Super FE** was applied with an allowance above the nominal diameter during the rotation of the journals installed in the lathe. After the **Chester Metal Super FE** material had cured, a machining was performed to obtain the desired surface smoothness.
