USER: Calciferous Plant

DESCRIPTION OF THE PROBLEM: As a result of a utilization of the 3-level transmission gear WTM 1250 made by Gear-motor Factory in difficult conditions (considerable dust), the bearing of the symbol 22240 (internal diameter of 200mm) was turned at the top of the roll. The top of the roll was rubbed off and the wear and tear of the roll amounted to 0.2mm.

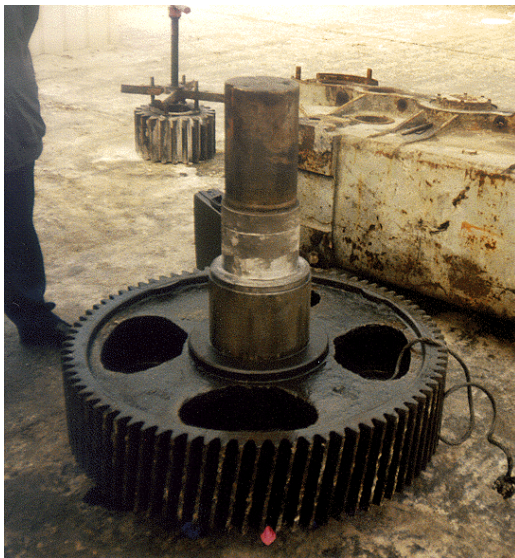
DESCRIPTION OF THE REPAIR: It was decided to glue the bearing in the roll with **Chester Molecular C-36** adhesive. The surface of the roll's top was cleaned with a manual grinder and abrasive paper (photo No.1). Then the top and the internal surface of the bearing were defatted several times with **Chester Fast Cleaner**. The adhesive was applied in both surfaces and the screw line, and then the bearing was placed on the top (photo No.2).

ACHIEVED EFFECTS: Thanks to the application of the adhesive made by Chester Molecular, the time of the reductor's renovation was considerably shortened. The reductor has been functioning already for 6 months without any problems.
