USER: Lime Industry Plant

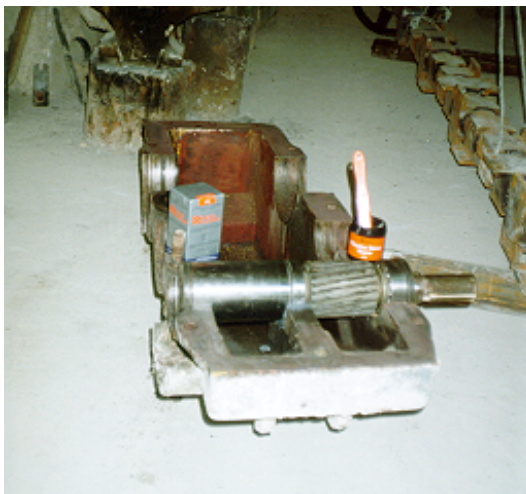
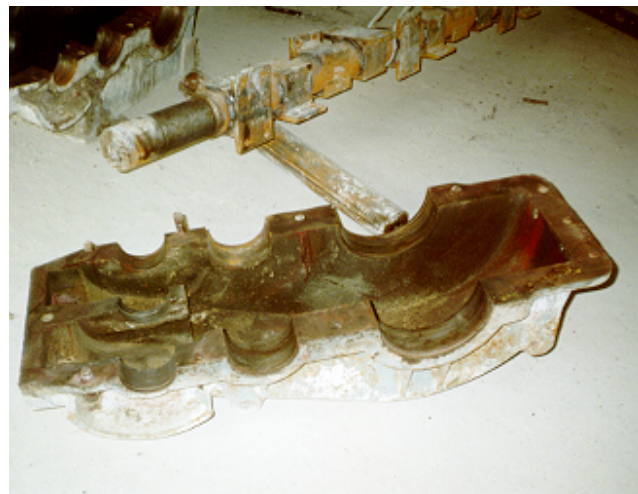
**DESCRIPTION OF THE PROBLEM:** There was noted a tumble of the seat under the rolling bearing of the rear shaft neck attacking the WD 650 transmission gear.

**DESCRIPTION OF THE REPAIR:** Due to the one-directional tumble of the material of the seat, the rolling bearing was centered with the help of a metal wedge and located in the part of the seat not damaged. The upper and bottom body of the seat was polished and degreased with **Chester Cleaner**. The lack in the seat material was supplemented with **Chester Metal Super**. The external bearing track and the adjacent fragment of the pressure sleeve were lubricated with **Chester Release Agent** separator before they were inserted. The separator was also used to reconstruct the shape of the edge of the groove shaping the cover with the pressure sleeve (in the bottom part of the body), which was torn off, by copying it from the original cover. Both bodies were adjusted. The disassembly was performed after two days.

**ACHIEVED EFFECTS:** After the separation of the upper and bottom part of the body, the user dismantled the cover, the bearing sleeve with the shaft, confirming an ideal representation of the bearing. The wedge setting the bearing was left in the place of its initial fastening, additionally strengthening the bearing system. The user plans a renovation of subsequent transmission gears and a crusher with materials of Chester Molecular.
