USER: Deawoo Motor Poland

DESCRIPTION OF THE PROBLEM: Short run castings appear during the process of casting the block of the engine for Polonez 1600 car in the place of the location of pins fastening the head, which make it impossible to drill and thread openings for the pins (photo No. 1). Such castings have been scrapped and re-cast so far. It was decided to regenerate the blocks with Chester Molecular materials in July this year.

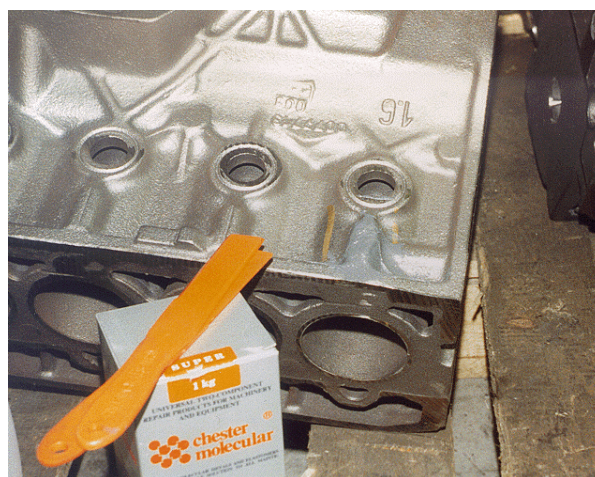
DESCRIPTION OF THE REPAIR: The place of the short run casting was defatted with **Chester Cleaner**. After the defatting agent evaporated, **Chester Metal Super** was placed (photo No. 2).

ACHIEVED EFFECTS: The performed regeneration prevented the scrapping of engine blocks. After tests of the drilling and threading of openings for the pins of the head, the technology of the repair with materials of Chester Molecular obtained a complete approval.
