No. 058n

Customer: Ironwork

Made by: M.Sc. Eng. A. Sitko - CHESTER MOLECULAR - Opole

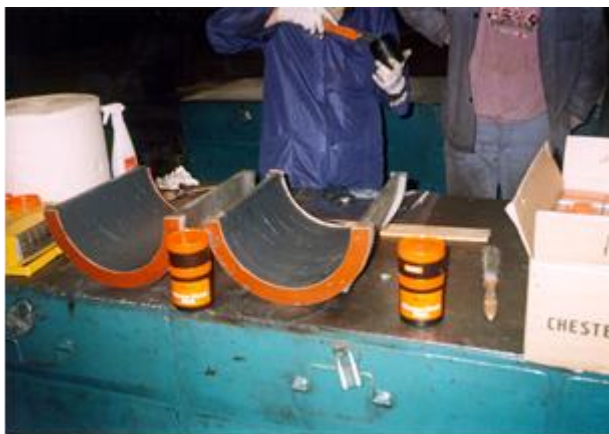
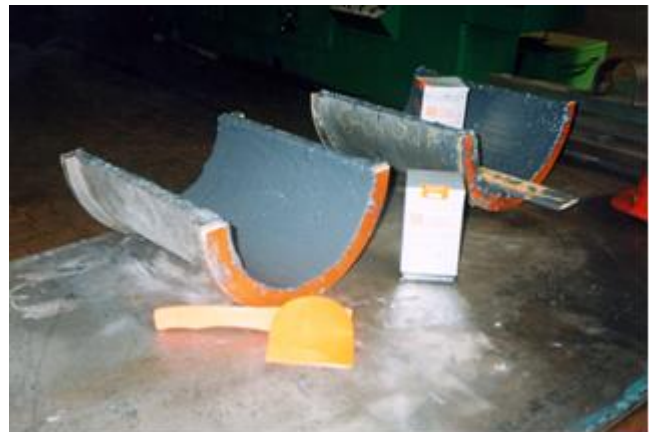
PROBLEM DESCRIPTION: The bronze bushing of the counterbalance shaft of the pipe alongator has worn out as a result of operation. The repair consists in inserting a new brown bushing in place of the worn bushing.

DESCRIPTION OF THE REPAIR: The bush was made of ordinary carbon steel, with a hole 8 mm larger than the nominal size. The inner surface of the bush was degreased with **Chester Fast Cleaner F-7** and lined with **Chester Metal Slide**. After the Chester material was pre-cured, the bushing was machined to remove excess Chester Metal Slide material to a nominal size.

ACHIEVED EFFECTS: This type of regeneration enables the elimination of the bronze bushing, replacing it with a steel bushing lined with Chester Metal Slide. Worn bronze bushings can also be regenerated in the same way. Previously, the worn bronze bushings were scrapped.
