**Customer: Municipal Heating Plant**

**Consultation: M.Sc. Eng. Leszek Kupras - CHESTER MOLECULAR**

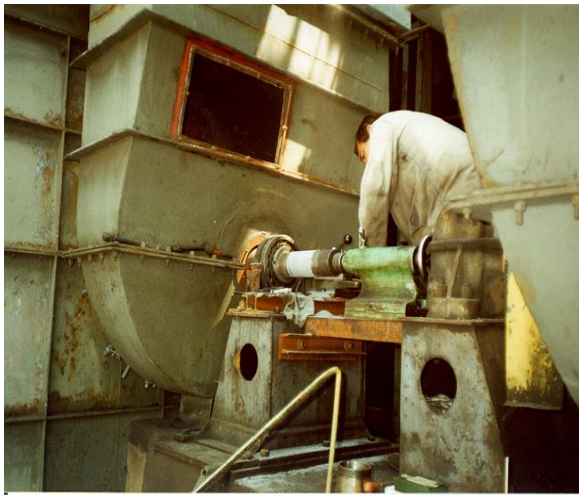
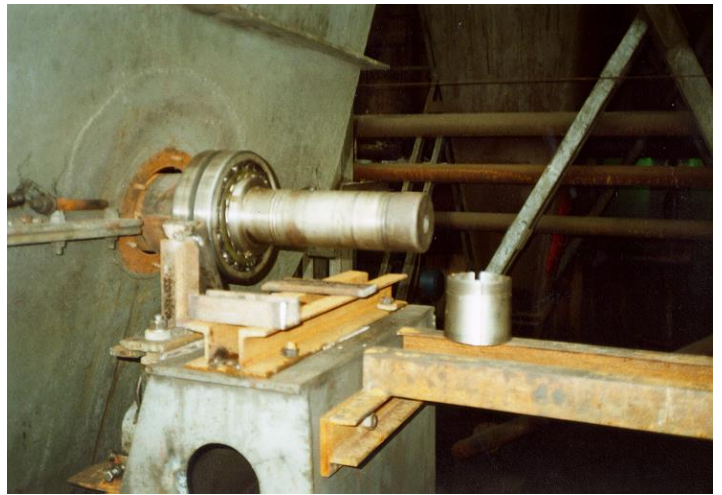
**PROBLEM DESCRIPTION:** In the operation of the exhaust draft fans, a clearance appeared between the bearing sleeve and the shaft journal  $\phi$  100. The bearing node required renovation due to the inability to eliminate the backlash by tightening the nut.

**DESCRIPTION OF THE REPAIR:** There were grooves (approx. 12 mm x 2 mm) on the journal, leaving furrows approx. 2 mm wide. After degreasing with **Chester Fast Cleaner F-7**, **Chester Metal Super FE** material was applied. After curing, machining was performed with a "field" lathe. The shaft rotation was achieved by blowing compressed air on the fan blades.

**ACHIEVED EFFECTS:** The shaft with the fan did not require any costly and troublesome disassembly. The possible occurrence of difficult grinding of the lined surface as well as thermo-mechanical stresses and corrosion related to overheating of the shaft disqualified the possibility of traditional repair with padding. The positive effect of the shaft regeneration with Chester Molecular materials fully confirm the validity of the adopted solution.
