No. 079n

Customer: Cement and lime factory

Consultation: M.Sc. Wojciech Łukanowski - CHESTER MOLECULAR - Bydgoszcz

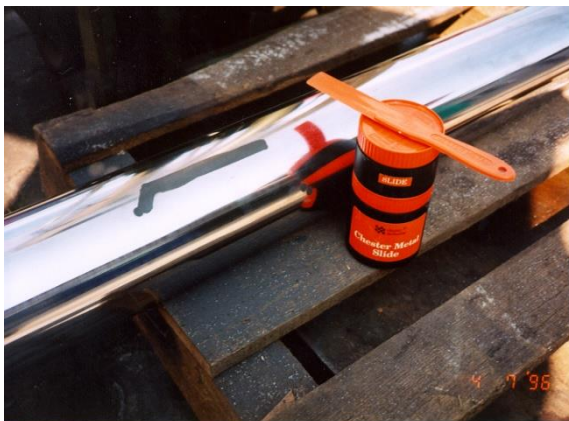
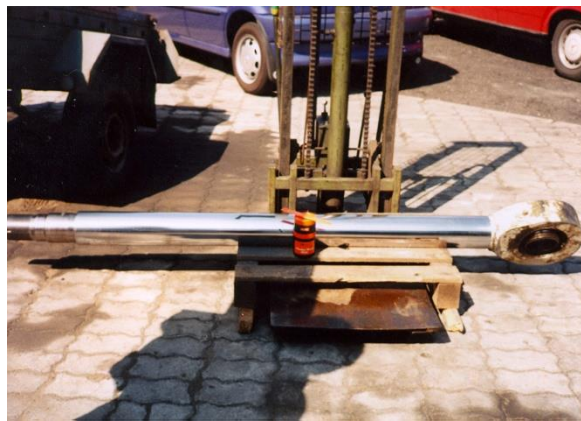
PROBLEM DESCRIPTION: In the excavator, the cylinder piston rod with a diameter of 180 mm and a length of about 2 m has failed. A deep scratch has formed on the working surface of the piston rod (sealed). There was a leak and a drop in the operating pressure at this point, which made it impossible for the piston rod to continue working. As the scratch was too deep for regeneration with the galvanic method, it was decided to supplement it with Chester Molecular material.

DESCRIPTION OF THE REPAIR: The scratch in the piston rod was deepened with a high-speed grinder. The side edges were additionally processed with a disc milling cutter to form a "dovetail". The ends of the incision were drilled and threaded. The regenerated surface was sandblasted with silicon carbide and degreased three times with **Chester Fast Cleaner F-7**. Then **Chester Metal Slide** was applied. After the composite cured, the surface was hand treated with sandpaper.
