**Customer: Power engineering repair plants**

**Made by: Brigade of repair plants**

**Supervisor: M.Sc.Eng. Leszek Kupras - CHESTER MOLECULAR - Łódź**

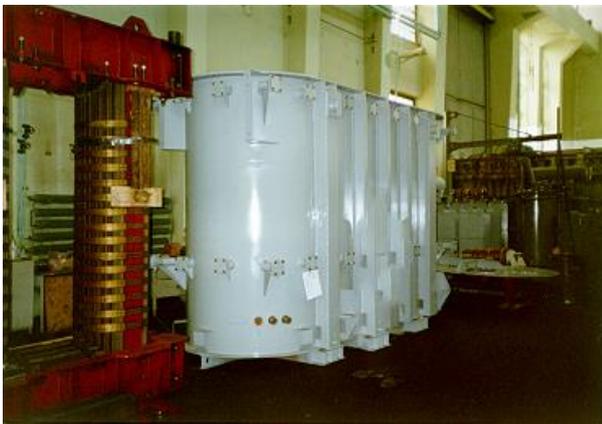
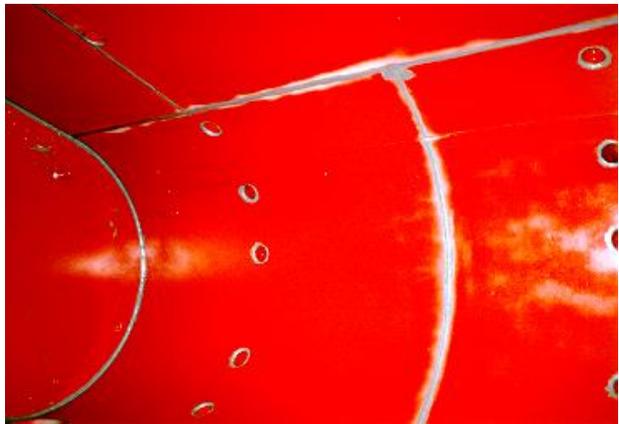
**PROBLEM DESCRIPTION:** In the operation of transformers, a significant problem is the leakage of transformer oil through leaky welds connecting the sheets. Despite the great diligence of welders, it turns out that the problem of "sweating" of welds occurs very often, which requires welding corrections during tightness tests or at the user's.

**DESCRIPTION OF THE REPAIR:** Prophylactic covering of the entire length of the welds inside the transformer tank with **Chester Metal Ceramic F** was proposed. Sandblasted or sanded welds after degreasing **Chester Ultra Fast Degreaser F-6** were covered with the above-mentioned material using a short, stiff brush.

**ACHIEVED EFFECTS:** The plant had previously performed a leak test of a small tank, deliberately defective welded and secured with the above-mentioned technology. A pressure test of 0.8 MPa with the use of a penetrator and a lamp showed 100% tightness of the protected joints. Preventive protection of joints will allow you to avoid costs related to warranty (or post-warranty) repairs resulting from the need to remove leakage or seepage of oil outside the device.
