Customer: Municipal Water and Sewerage Company

Made by: M.Sc. Eng. Piotr Piątek - CHESTER MOLECULAR -Lublin

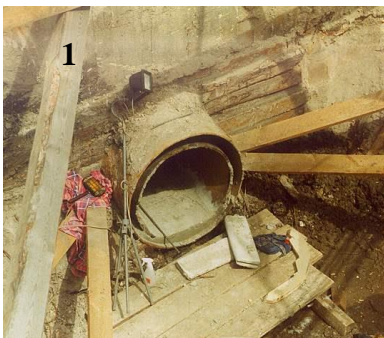
PROBLEM DESCRIPTION: In the pipeline ϕ 900 mm (photo 1) transporting raw sewage from the sand trap, a crack occurred at a length of approx. 1.5 m (photo 2). The only repair option was to seal the pipe with Chester Molecular materials.
