No 305n

User: Paper plant

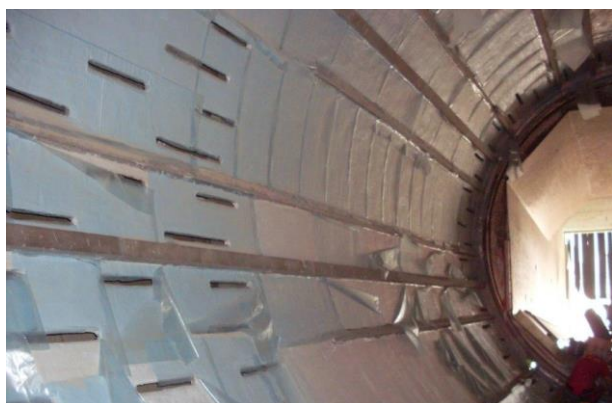
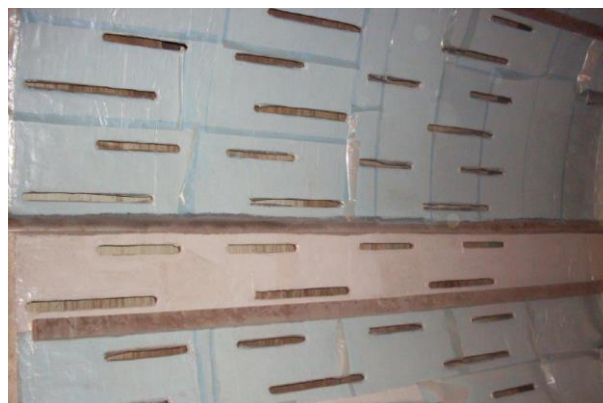
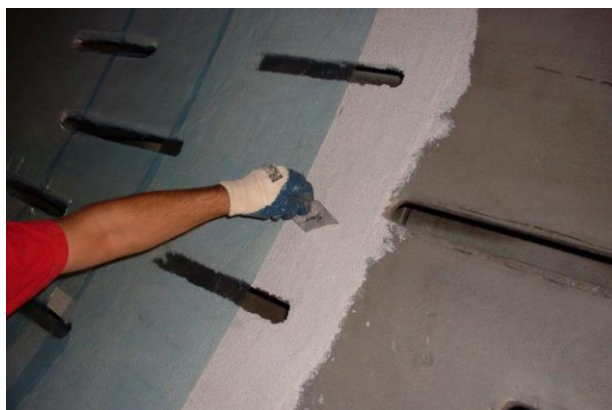
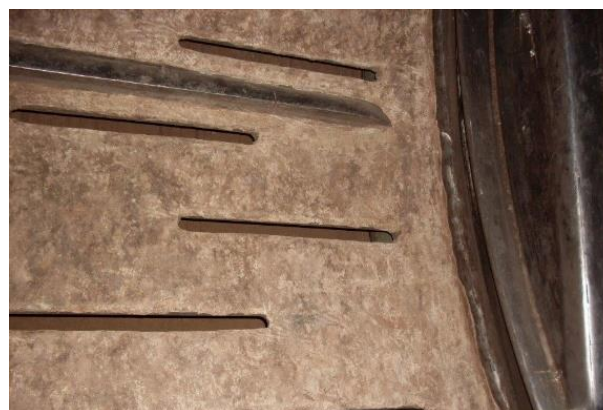
PROBLEM DESCRIPTION: The debarking drum is subject to erosive wear during operation. This wear is caused by the friction of the wood rollers (logs) against the inner surface of the drum, as well as the erosive action of sand and earth on the surface of the barked wood. The previously used method of repair consisting in periodic replacement of the most damaged elements of the drum was rejected by the user due to the unacceptable durability of such regeneration and the related maintenance downtime. In order to extend the failure-free working time of the debarking drum, alternative methods were sought. Chester Molecular proposed to protect the inner surface of the drum with **Chester Surface Protector B**.

DESCRIPTION OF THE REPAIR: Before protecting the entire drum, the user decided to test the proposed solution on a small fragment - approx. 10 m² of surface. The selected fragment, most susceptible to wear, was properly prepared - washed, sandblasted and degreased with **Chester Fast Cleaner F-7** and then protected with a 4 mm **Chester Surface Protector B** coating.

ACHIEVED EFFECTS: After about 6 months, the protected part of the drum was inspected. No damage or wear was found. User decided to protect the entire inside surface of the drum. Every few months the device is inspected. After 5 years, no significant changes in the appearance and thickness of the coating were found.
