Customer: Mechanical Plants

Made by: Brigade of repair plants

Supervision: CHESTER MOLECULAR - Rzeszów

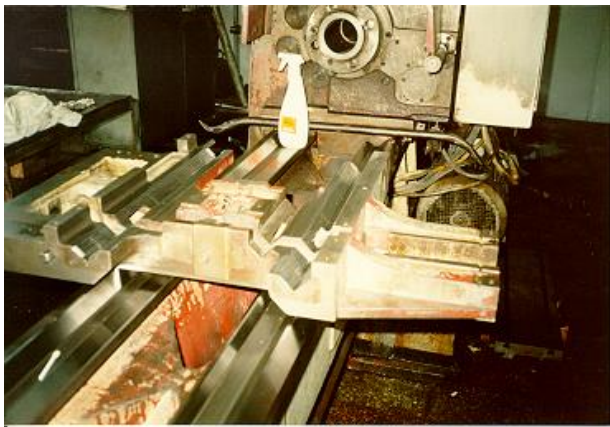
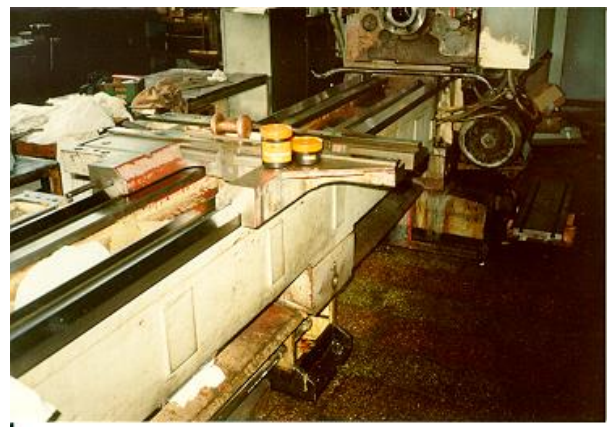
PROBLEM DESCRIPTION: As a result of operation, the bed of the lathe support has worn out. The renovation technology was used, consisting in making spacers on the support.

DESCRIPTION OF THE REPAIR: The surface was roughened (planed) and degreased with **Chester Fast Cleaner F-7**. At the ends of the bottom bracket there are previously fitted spacers for precise levelling and alignment of the bottom bracket with the spindle. After applying the **Chester Metal Slide** material (with a small allowance), the carriage was placed on the lathe bed previously covered with a separator. After the Chester material was cured, the bottom bracket was removed and the excess material was removed (milling).

ACHIEVED EFFECTS: The repair significantly shortened the time spent on renovation using the traditional method.
