User: Soda production plants

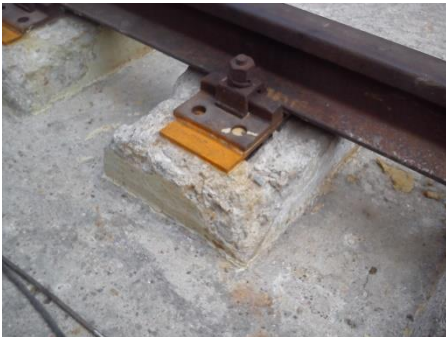
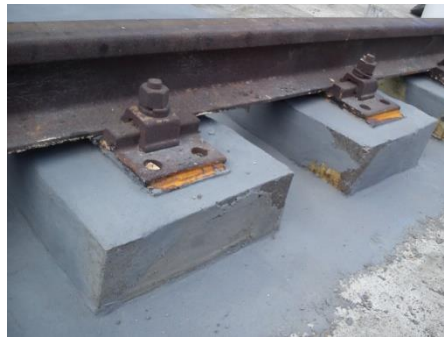
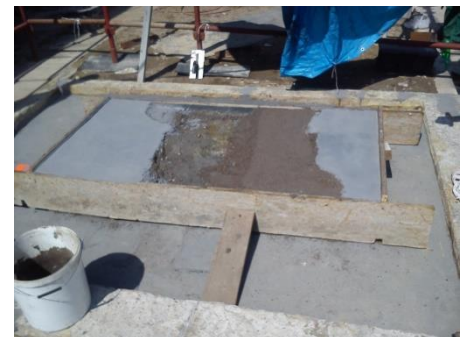
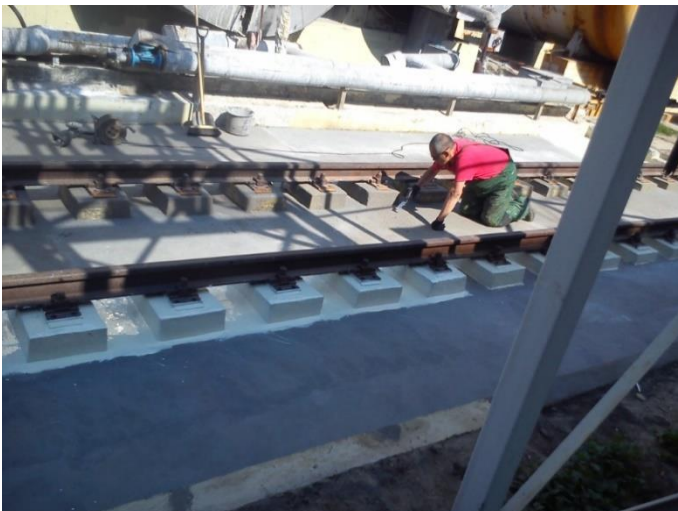
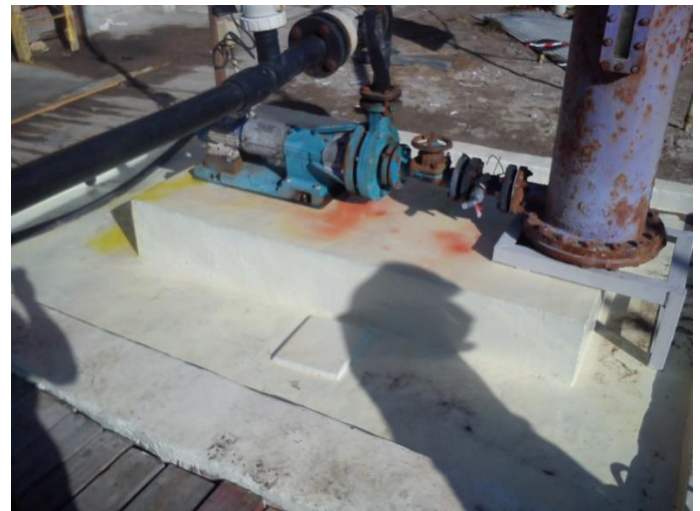
DESCRIPTION OF THE PROBLEM: During operation, the concrete surfaces of the drip tray were damaged - a station for pumping concentrated acids (sulfuric and hydrochloric acid) from rail tankers to stationary tanks. Damage was caused by acid leaks and impacts from reinforced ends of reloading hoses. The subgrade, pump foundations and sump tubs were qualified for repair. Previously performed repairs with traditional materials based on cements did not work - after a few months the applied layers were loosened. This was caused by the penetration of acids into local surface damage and constant moisture of the repaired places with water seeping from the substrate

DESCRIPTION OF THE REPAIR: Chester Molecular technology with epoxy products was selected. Degraded and loose concrete fragments were chipped off and removed. Everything has been sandblasted, dusted and washed. **Chester Quartz LVY** was used to recreate the original shapes of the damaged elements and level the surface. It is a product that can be applied to damp and oily substrates. After initial curing, the whole was covered with **Chester Surface ProtectorE**.

ACHIEVED EFFECTS: The repair was made within 6 days. The Chester Quartz LVY - Chester Surface Protector E repair system completely protects the drip tray against both mechanical damage and damage caused by leaks of the pumped media. A 60-month warranty was given for the repair.
